## PLASTER INVESTIGATION

AN AREA OF FOCUS — CRACKING OF PLASTER AT UPPER COLUMN CAPITALS AND THEIR ASSOCIATED RIBS.

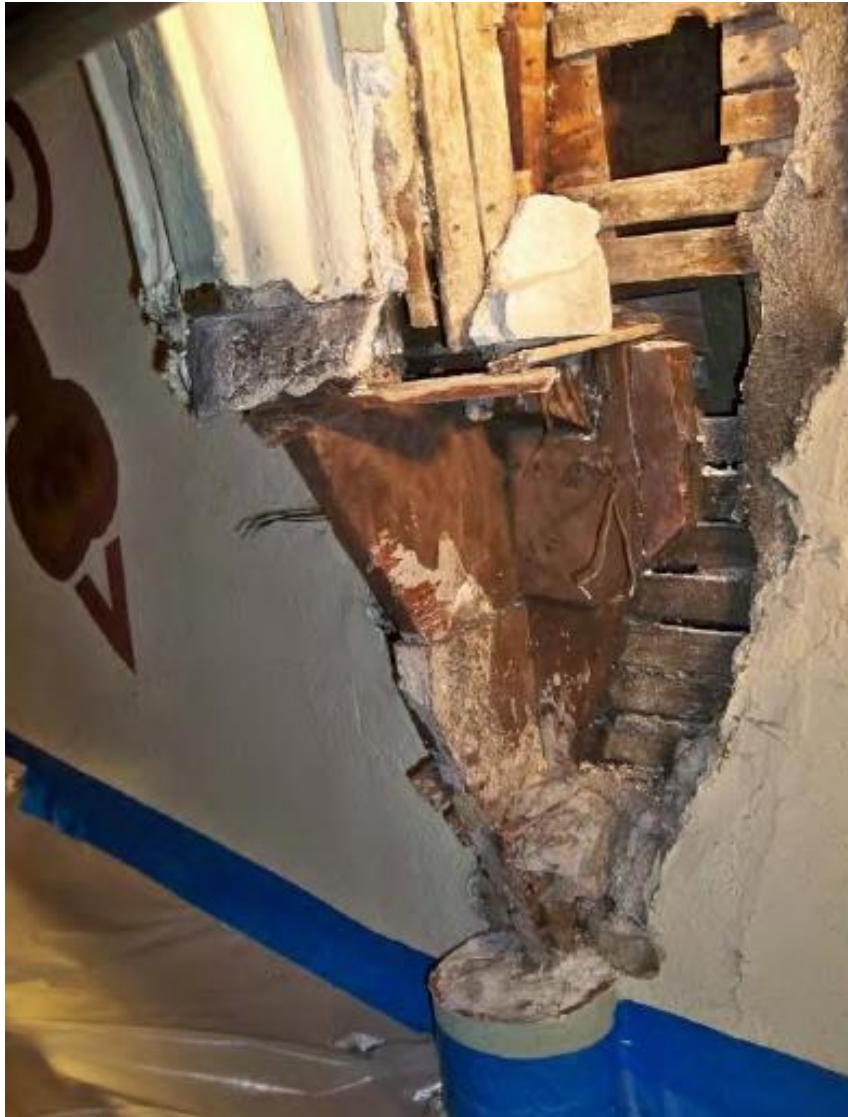
COLUMN UPPER CAPITAL  
WOODEN BRACKET SUPPORT  
GRADUAL LONG-TERM MOVEMENT  
RESULTING IN CRACKING WITHIN  
SUPPORTING RIBS

COLUMN CAPITAL WAS DISSECTED TO INVESTIGATE CONDITIONS AND CONSTRUCTION.

DISCOVERED OLD WOODEN SUPPORTS THAT HAVE SHIFTED DOWN AFTER 150 YEARS, CAUSING CRACKS WITHIN THE RIBS ABOVE THE CAPITALS.

PROPOSED STRUCTURAL REPAIR INVOLVES REPLACING OLD WOODEN SUPPORT BRACKETS WITH FIRMLY SECURED METAL BRACKETS.

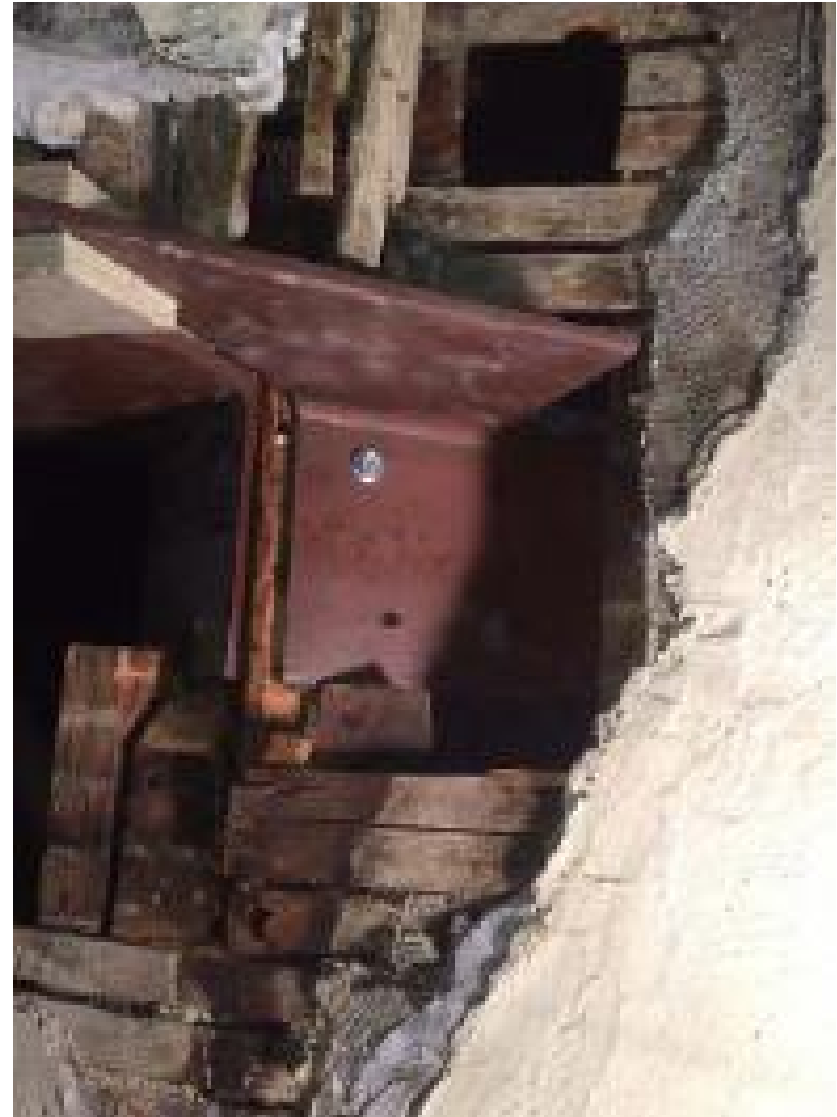
REPAIRED BY NEW METAL  
BRACKET SUPPORT

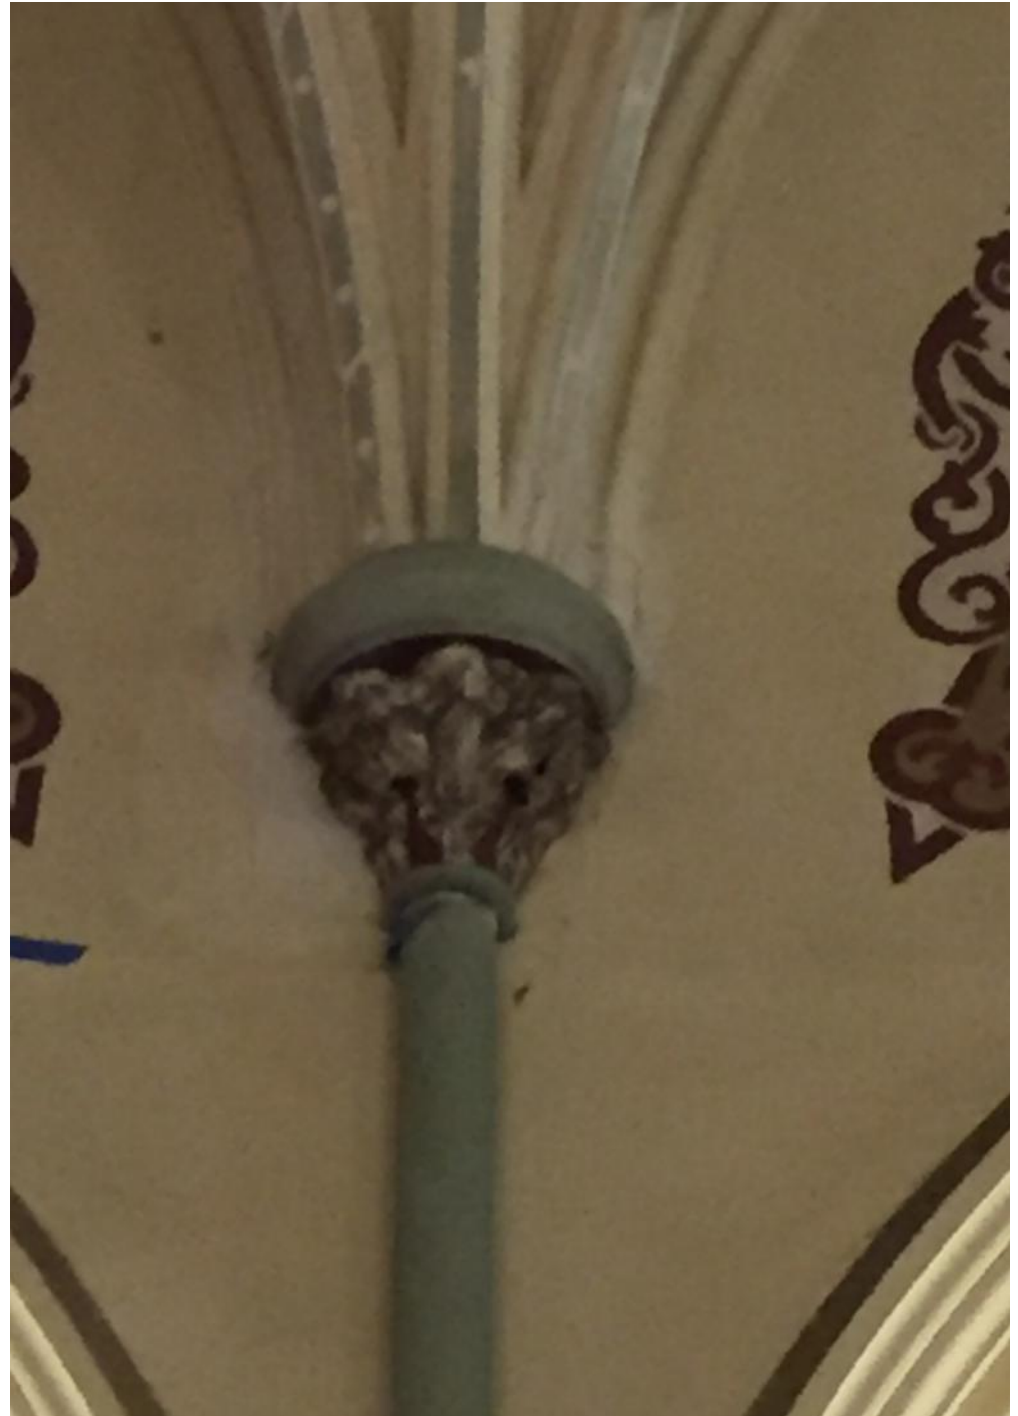
THE DISSECTED CAPITAL AND RIBS WERE REPAIRED BUT NOT REPAINTED, AS PICTURED TO THE RIGHT

ALL UPPER CAPITALS WERE REPAIRED IN 2016
