## PLASTER INVESTIGATION

AN AREA OF FOCUS — CRACKING OF PLASTER AT UPPER COLUMN CAPITALS AND THEIR ASSOCIATED RIBS.

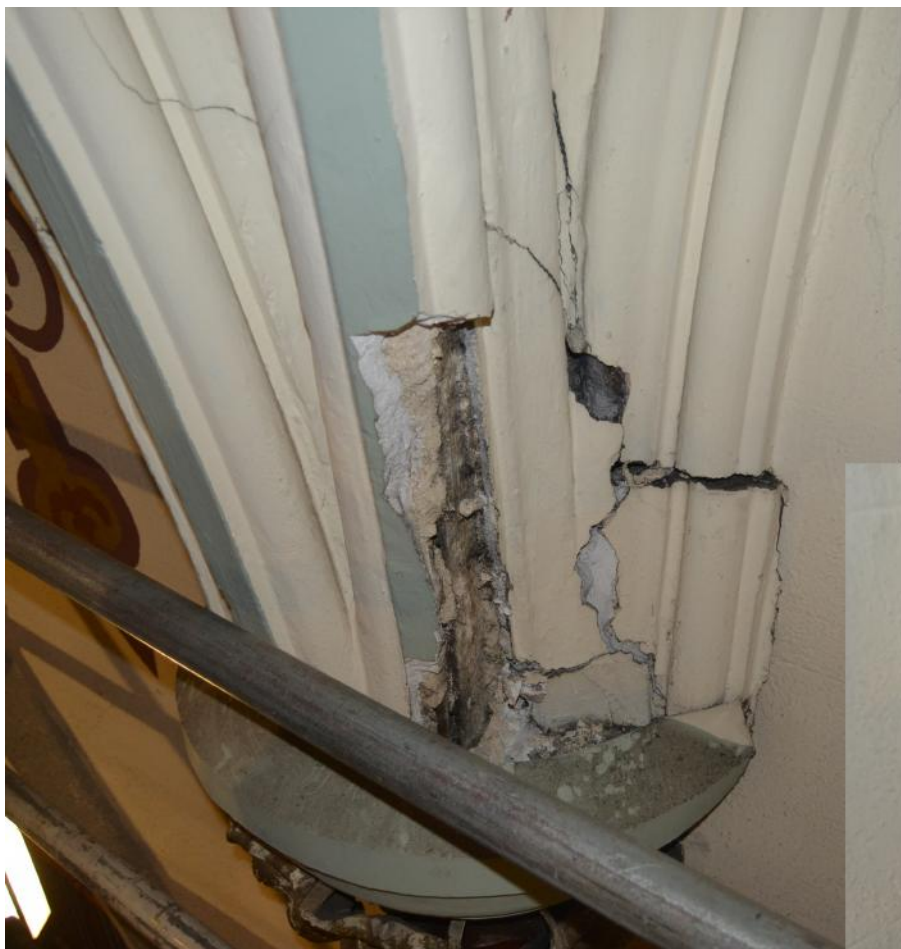
COLUMN CAPITAL WAS DISSECTED TO INVESTIGATE CONDITIONS AND CONSTRUCTION.

DISCOVERED OLD WOODEN SUPPORTS THAT HAVE SHIFTED DOWN AFTER 150 YEARS, CAUSING CRACKS WITHIN THE RIBS ABOVE THE CAPITALS.

PROPOSED STRUCTURAL REPAIR INVOLVES REPLACING OLD WOODEN SUPPORT BRACKETS WITH FIRMLY SECURED METAL BRACKETS.

THE DISSECTED CAPITAL AND RIBS WERE REPAIRED BUT NOT REPAINTED, AS PICTURED TO THE RIGHT

ALL UPPER CAPITALS WERE REPAIRED IN 2016
